# Longs Pass Avalanche Fatality

## January 9th, 2026

Report by Katie Warren & Payton Schiff

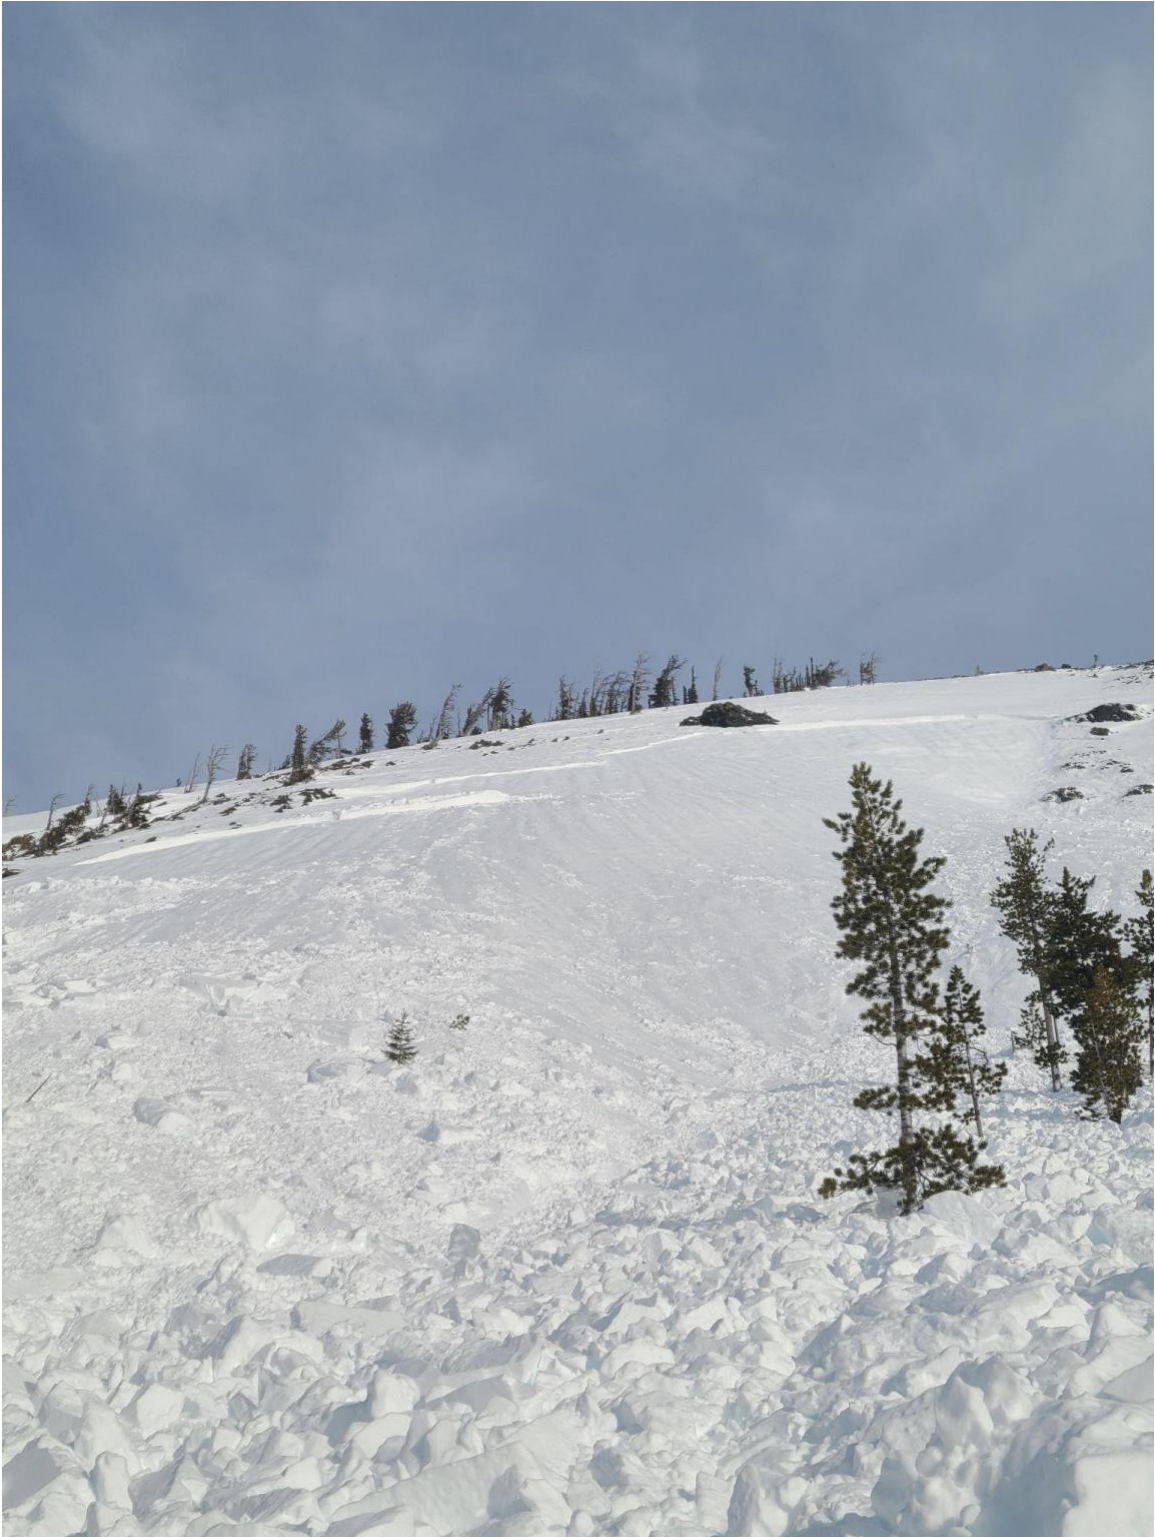
The 4th skier to descend likely triggered the avalanche on his first turn down the slope. The slab was much thinner in this area near the prominent rock features where the group transitioned and began downhill. In wind drifted areas along a subridge on the western portion of the path, as well as in a minor concave gully near the slide's eastern flank, the slab was thicker. The avalanche failed on a melt-freeze crust from a rain event in early January (Image 1). A few rounding faceted grains could be found above the crust in a crown profile, but they did not create a distinguishable layer. To the east of the rock feature, the slab fractured directly across the slope, terminating at another section of exposed rocks (Image 2 and 3). Along the western portion of the crown, the slab broke in a zigzag pattern, reaching exposed rocks along the lower-angle subridge. The sheltered areas below the starting zone contained softer snow, likely influenced by warming. As the hard slab debris (Image 4) flowed downslope, it picked up this moist snow, which may have helped it travel farther down the narrow gullies below. From what could be observed, the debris did not break any large, living trees.

**Image 2:** A view of the crown and starting zone. The avalanche was triggered directly below the prominent rock in the upper, center-right of the crown.

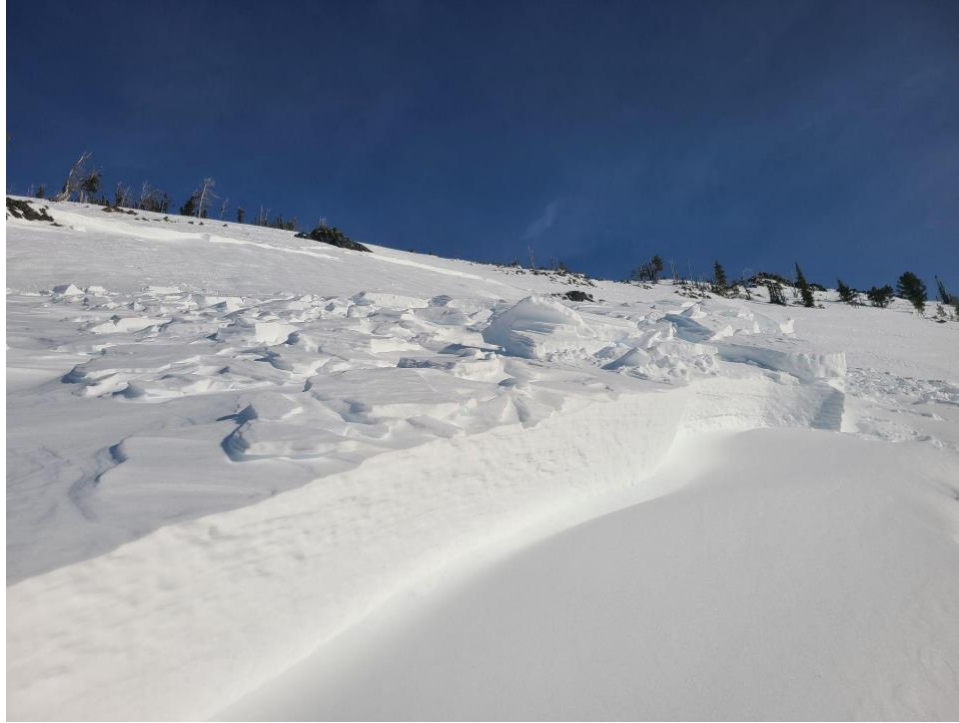
**Image 3:** View from the crown profile location looking east towards the rest of the crown line and starting zone.

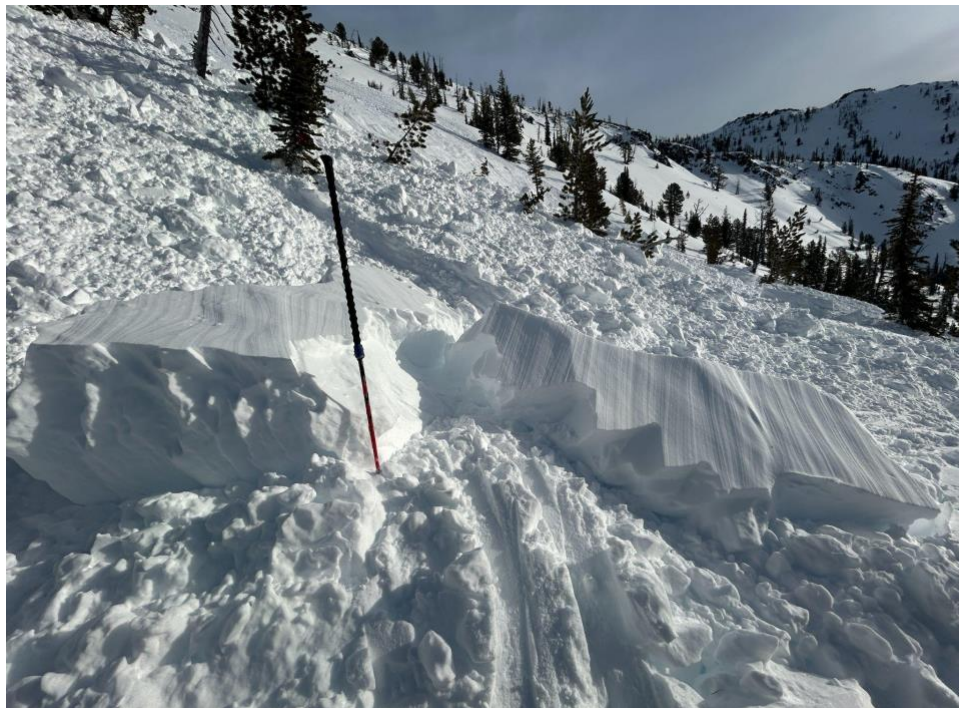
**Image 4:** Example of the large size and hardness of the avalanche debris.

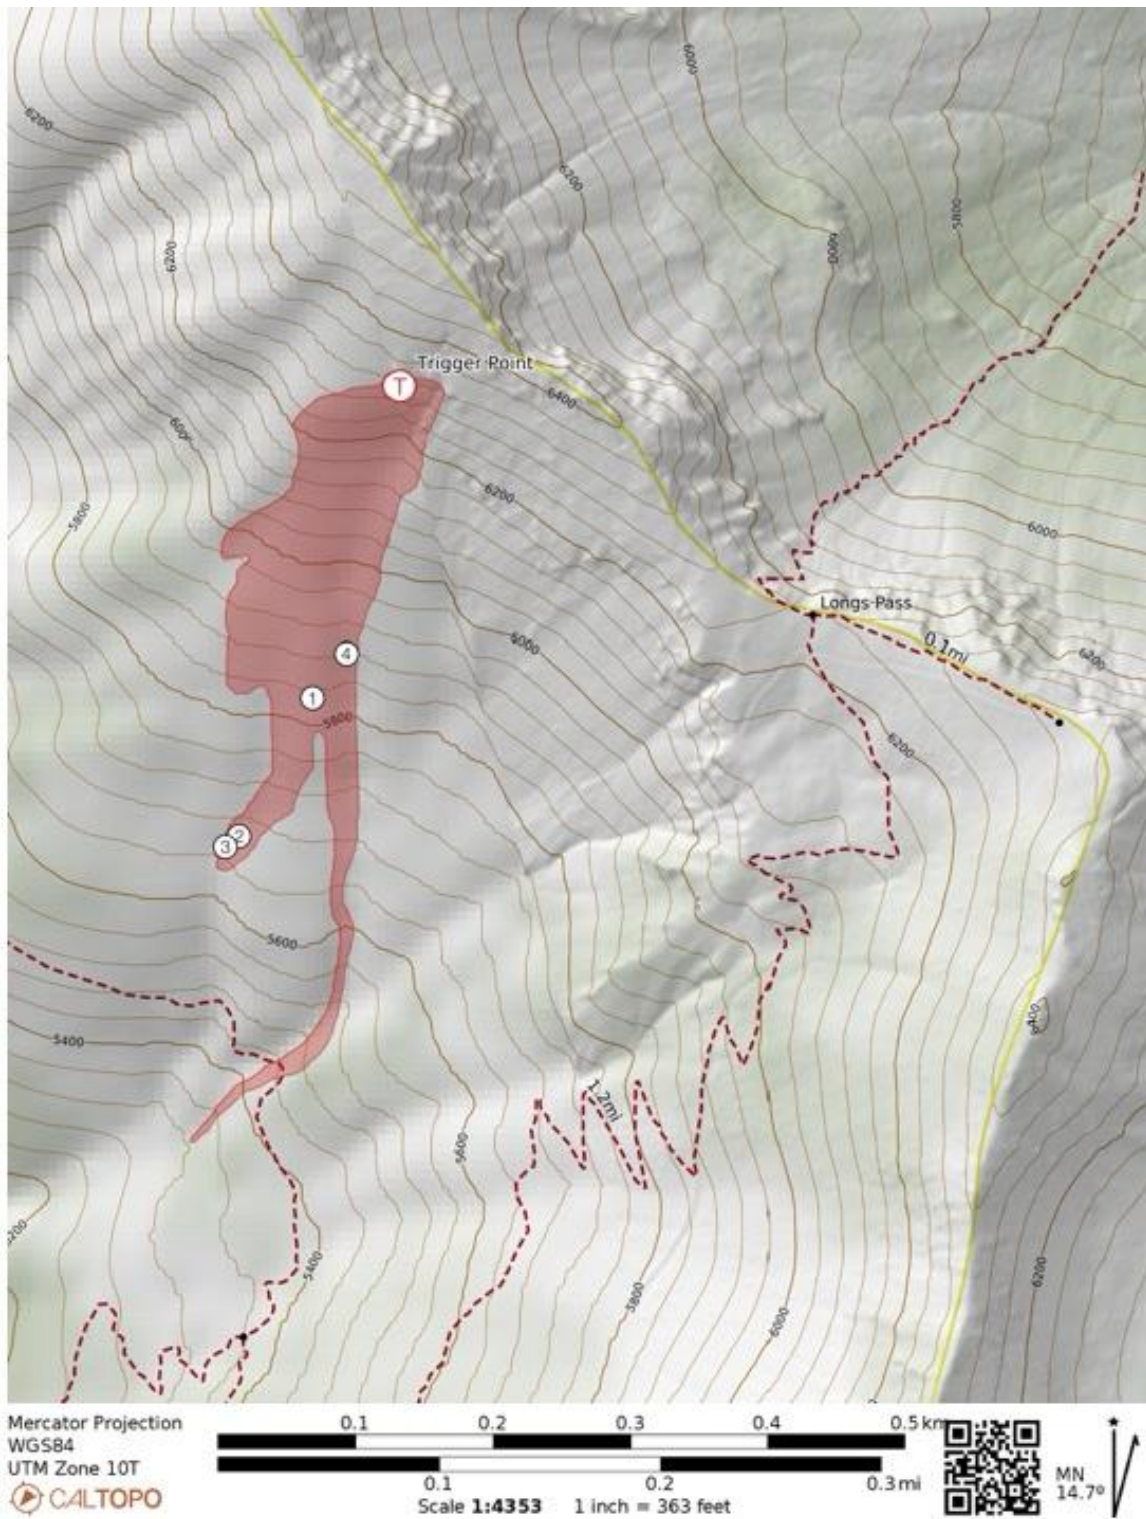
The starting zone contains slope angles of 38-40 degrees and is characterized by steep exposed rocks with minimal trees or other vegetation. The avalanche path quickly funnels into two steep gullies, separated by a low-angle rib. Both gullies have steep side walls and trees within the flow path. These two gullies eventually rejoin lower in the terrain (Image 5).

**Image 5:** Topographic map of January 9th, 2026, avalanche accident. The location where the avalanche was triggered (T), and the burial locations of skiers 1, 2, 3, and 4 are all shown.

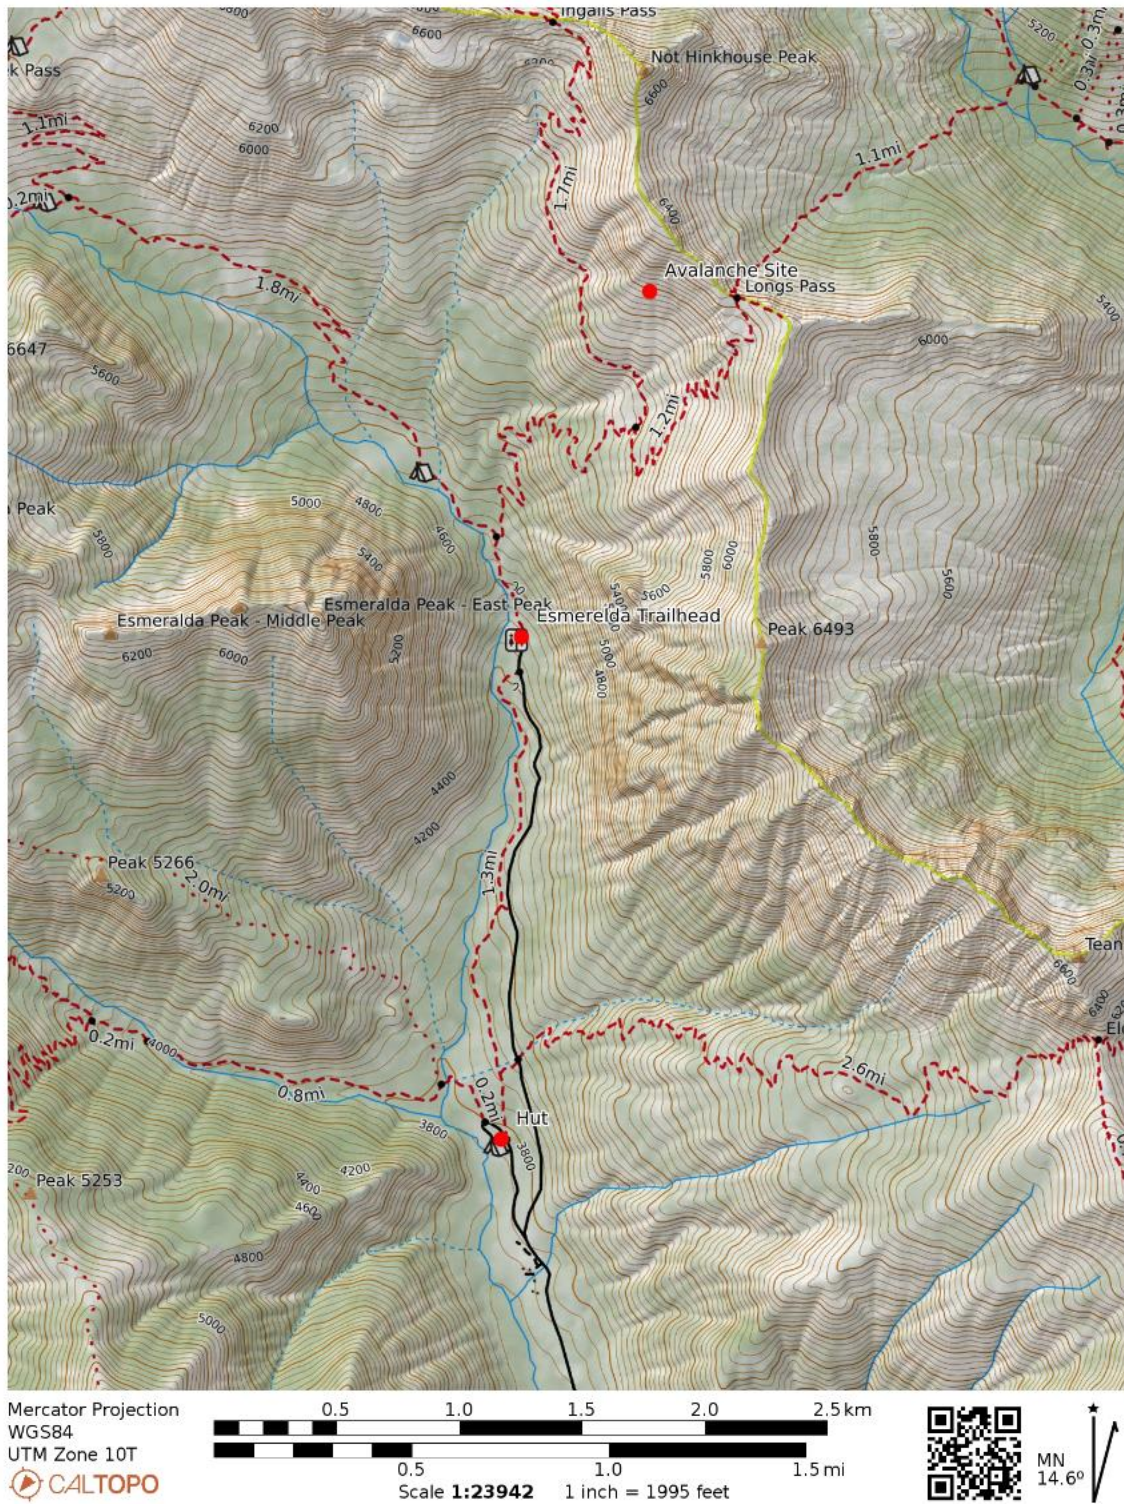
**Image 6:** Topographic map showing the location of the hut, Esmerelda Trailhead, and accident site.

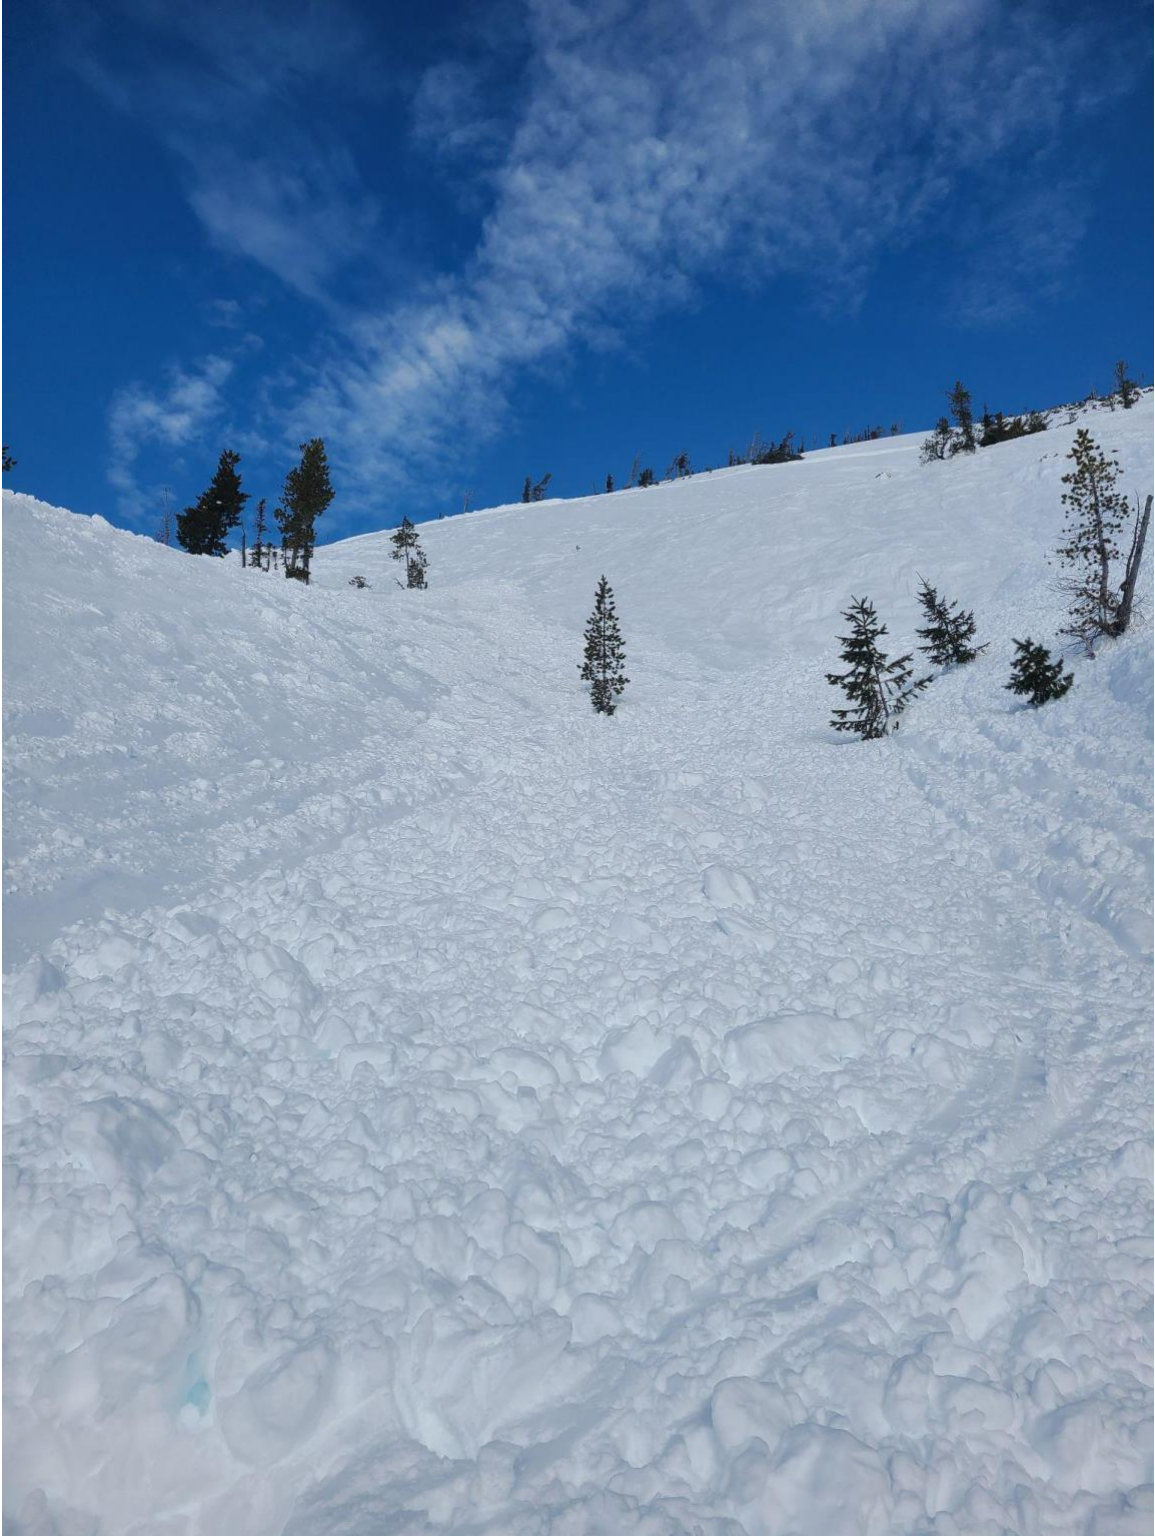
The avalanche caught and carried all four skiers. Debris from the slide split and flowed into both prominent gullies, reaching a maximum vertical fall of approximately 1000 ft. Skier 4 was buried up to his knees near the upper extent of the debris (Image 7). Skier 1 was carried approximately 50 vertical feet down the rib and attempted to deploy his avalanche airbag, but was unsuccessful. He came to rest partially buried with a significant knee injury. Skiers 2 and 3 were carried approximately 300 vertical feet into the western gully. One (Skier 3) was fully buried, and the other (Skier 2) was almost completely buried, with only a part of a ski visible.

**Image 7:** View uphill towards the crown from the partial burial location of Skier 4 in the eastern (skier's left) gully.

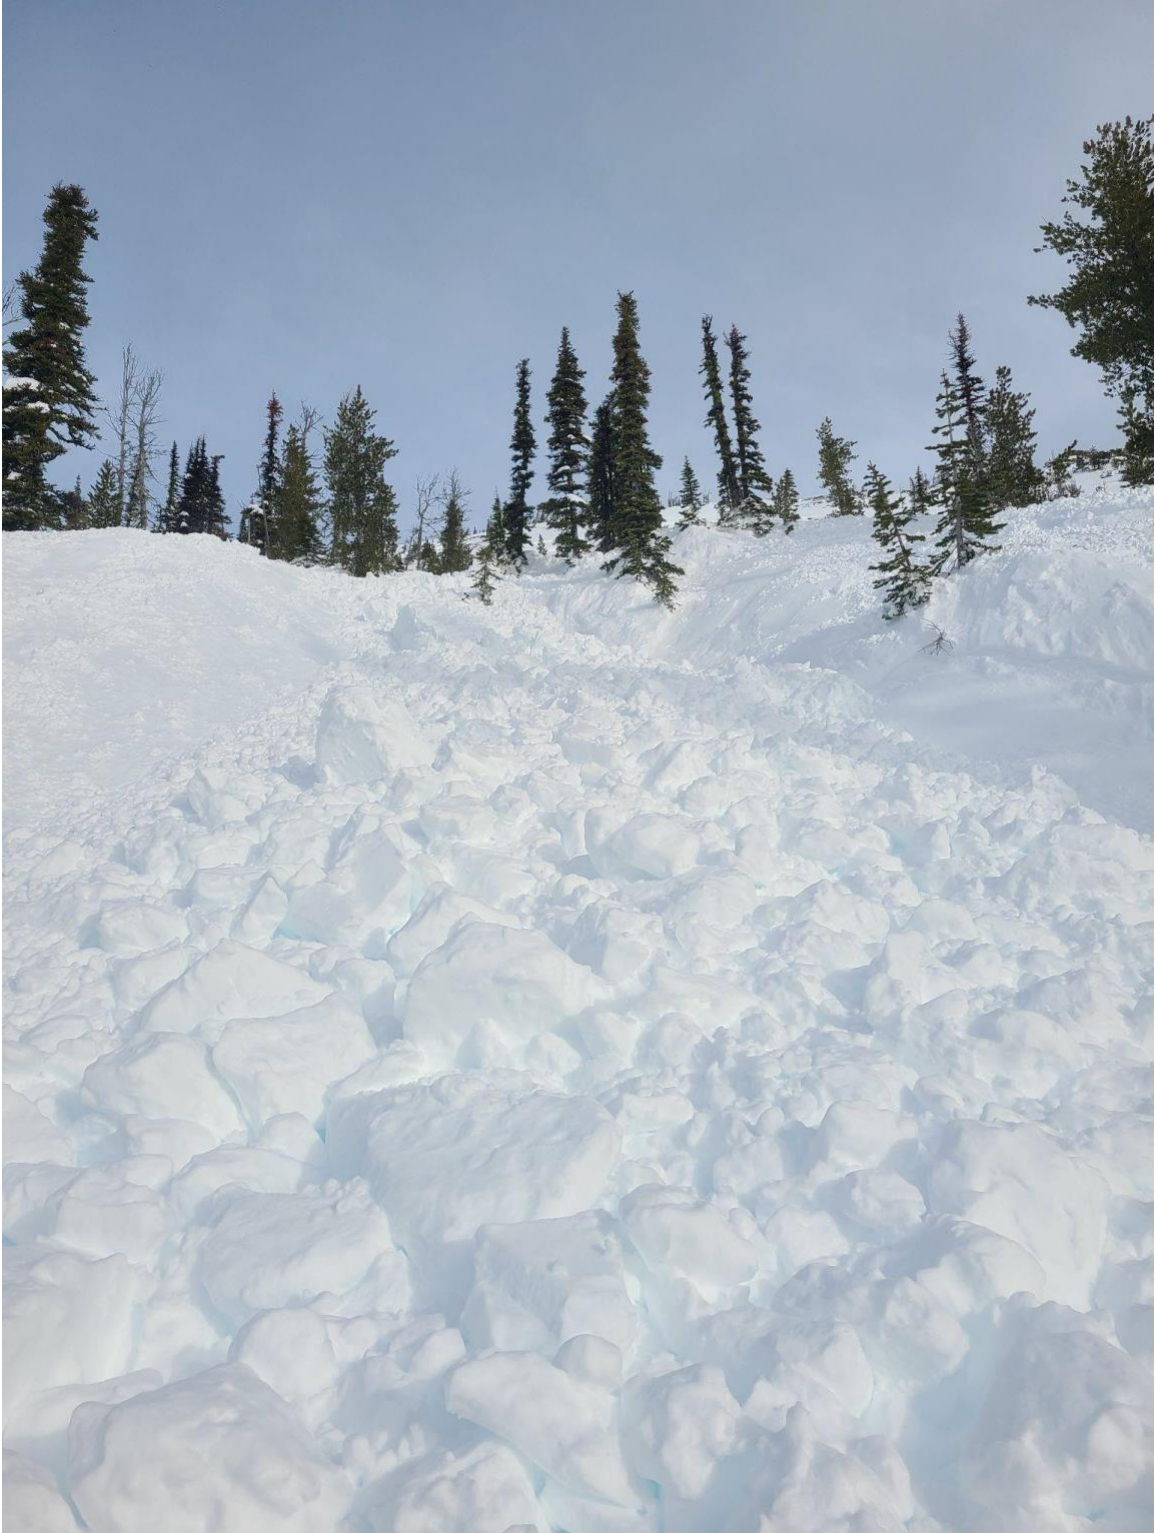
**Image 8:** View uphill in the western (skier's right) gully approximately 100 ft upslope from the burial location of Skier 3.

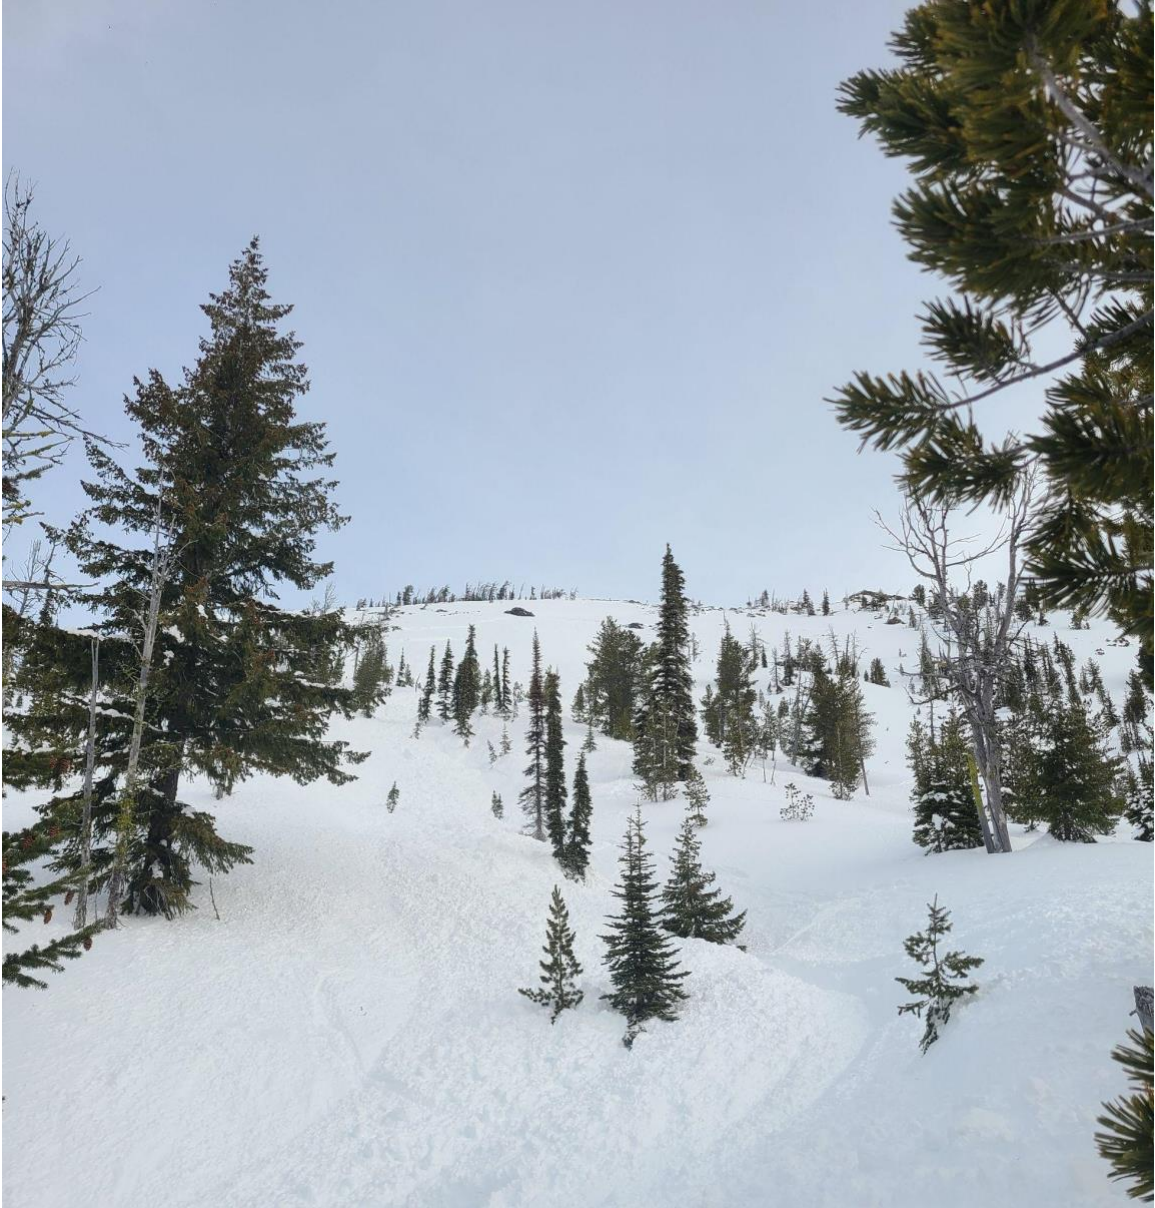
**Image 9:** View uphill in the western (skier's right) gully from the approximate burial location of Skiers 2 and 3.
